Tree Ecological Benefit Analysis and Risk Assessment

Location: 1810 University Avenue, Honolulu HI

Report of: Jolie Dollar, ISA Certified Arborist, WE-4963A

RE: Tree Risk Assessment

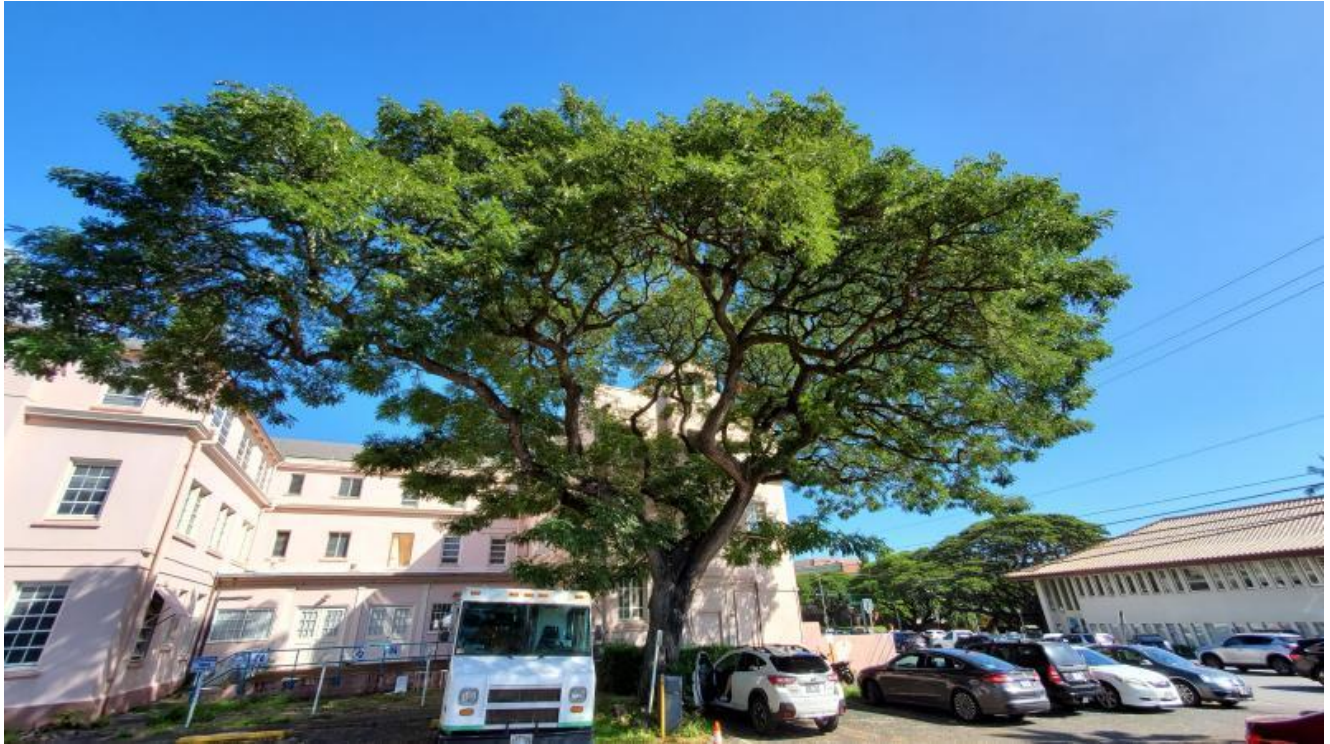
Subject Tree (T1)

Trunk Defects: No significant trunk defects are observed. There is a light attached to the trunk with a metal conduit running up from the ground.

Scaffold Branch/Tree Crown Defects: No significant scaffold branch or tree crown defects are observed.

Site Factors: The site is a planting strip within a parking lot. T1 is approximately 25 feet from a building and overhangs multiple vehicle parking spots.

Risk Categorization for T1: The risk rating for whole tree failure or a tree part failing, striking a target, and causing significant injury or damage within the next 36 months is **Low**.

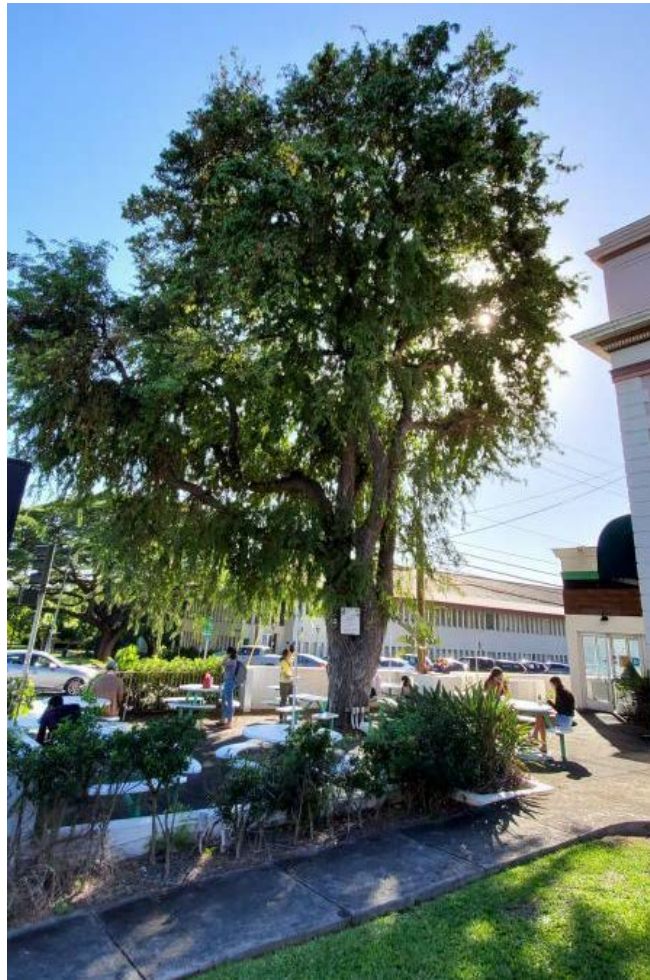
Subject Tree (T2)

Trunk Defects: No significant trunk defects are observed. There is a power line and light fixture mounted on the trunk and a sign nailed to the trunk.

Scaffold Branch/Tree Crown Defects: No significant scaffold branch or tree crown defects are observed.

Site Factors: The site is a planting circle within a public sitting area. The trunk of T2 is approximately 25 feet from a building and overhangs a public sitting area.

Risk Categorization for T2: The risk rating for whole tree failure or a tree part failing, striking a target, and causing significant injury or damage within the next 36 months is **Low**.

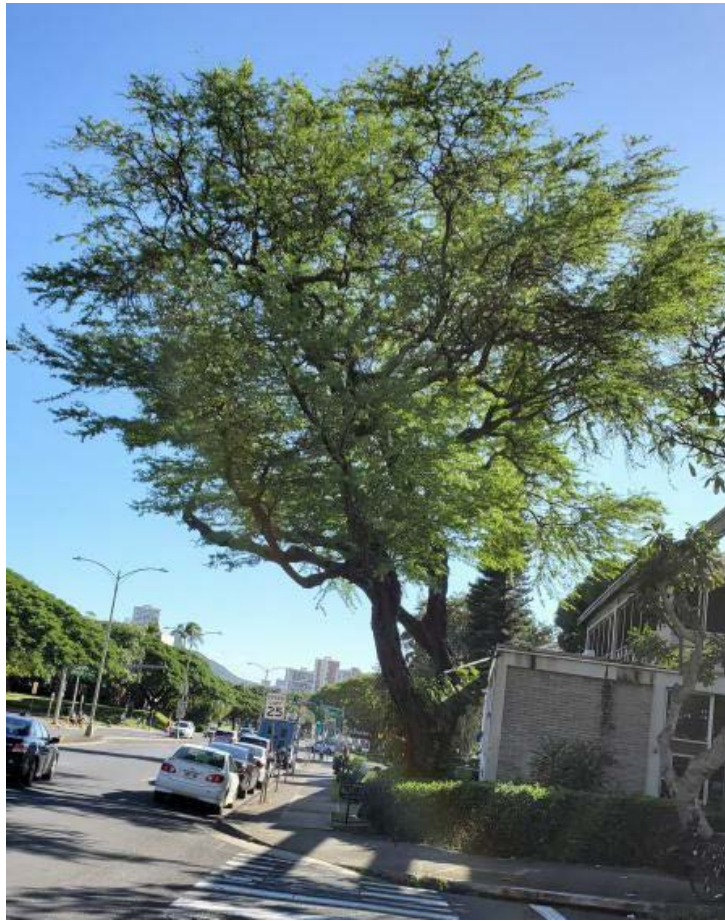
Subject Tree (T3)

- Species: The subject tree is identified as kiawe (*Prosopis pallida*).
- Height: The height of T3 is approximately 50 feet.
- Diameter at Breast Height (DBH): 46 inches
- Crown Class: T3 is dominant on this site and moderately exposed to winds.
- Crown Spread: The crown spread of T3 is approximately 85 feet by 70 feet.
- Crown Density: The crown density is approximately 50%, with 10% dieback.
- Live Crown Ratio: The live crown ratio of T3 is 50%.
- Form: T3 possesses an oval-shaped form.
- Tree Health: T3 appears to be in fair condition with some signs of decaying wood and dieback.

Risk Categorization of T3: The risk rating for whole tree failure or a tree part failing, striking a target, and causing significant injury or damage within the next 36 months is **Low**.

The main concern for T3 within the 36-month time frame and normal weather conditions is scaffold branch failure due to the presence of rotting and dead wood.

Based on the findings and conclusions of this assessment, STP does not find that risk reduction work is required at this time.

If the trees are retained, it is recommended that the tree owner retain a qualified arborist to conduct an inspection and assessment of the subject trees 12 months after the date of this inspection to re-evaluate condition, unless changes in tree or site condition occur first. It is further recommended that inspections be conducted according to a regular frequency recommended by the qualified arborist to re-evaluate tree condition, unless changes in the tree or site condition occur between each interval. In the instance of changes in tree or site condition that may affect tree structural integrity, an inspection and assessment should be conducted as soon as possible. Regular assessments will also permit the qualified arborist and owner to develop a better understanding of the risk character of the subject trees and develop a cost-effective management plan to best manage future failure risk.

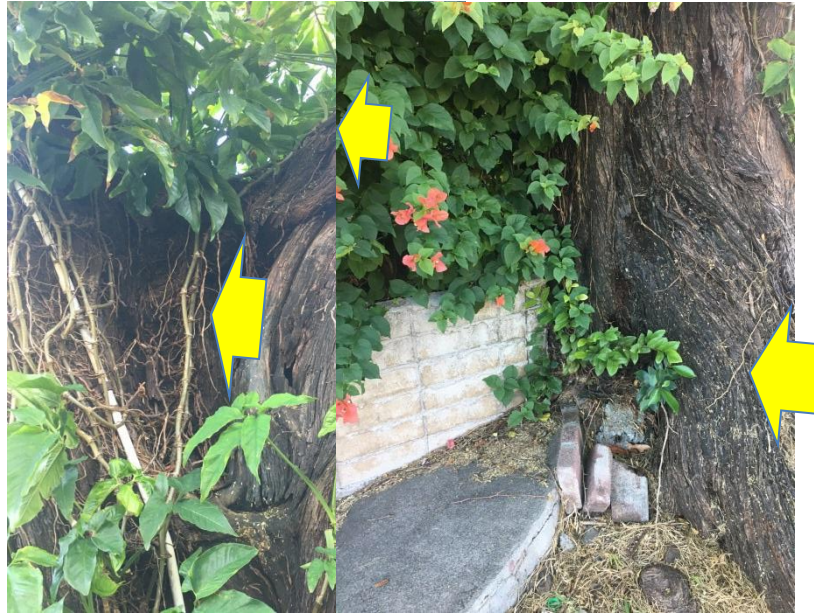
Trunk Defects: Dead and rotting wood are present in portions of the trunk, determined by sounding with a mallet and excavation of the cavities. However, there is good wound wood growth (healing) around the cavities.

Dead and Rotting Wood in Trunk and Scaffold Branch; Confined Planting Space

Scaffold Branch/Tree Crown Defects: Dead and rotting wood are present in portions of the scaffold branches, determined by sounding with a mallet and excavation of the cavities. However, there is good wound wood growth around the cavities.

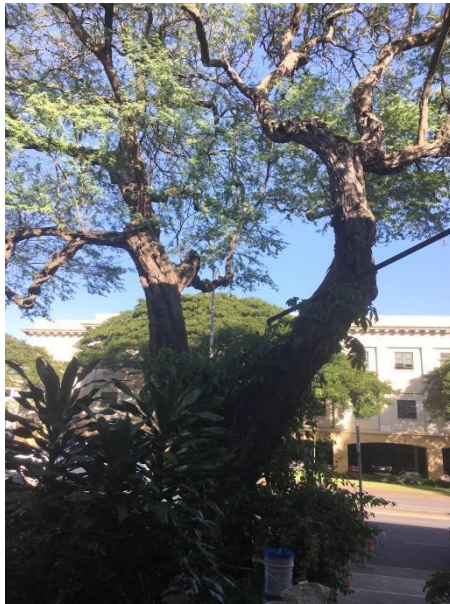
Site Factors: The site is a small, confined planting space along a public sidewalk and adjacent to stairs accessing the courtyard and entrance to the building. The trunk of T3 is approximately 20 feet from a building and overhangs sidewalks and building entryway. A rain gutter from the adjacent building flows out and over the top of the trunk where the scaffold branches are attached, probably contributing to the deterioration of the wood at this junction.

Rain Gutter Flow over the Junction of the Trunk and Scaffold Branches
