Tree Ecological Benefit Analysis and Risk Assessment

Location: 1810 University Avenue, Honolulu HI

Report of: Jolie Dollar, ISA Certified Arborist, WE-4963A

RE: Tree Risk Assessment

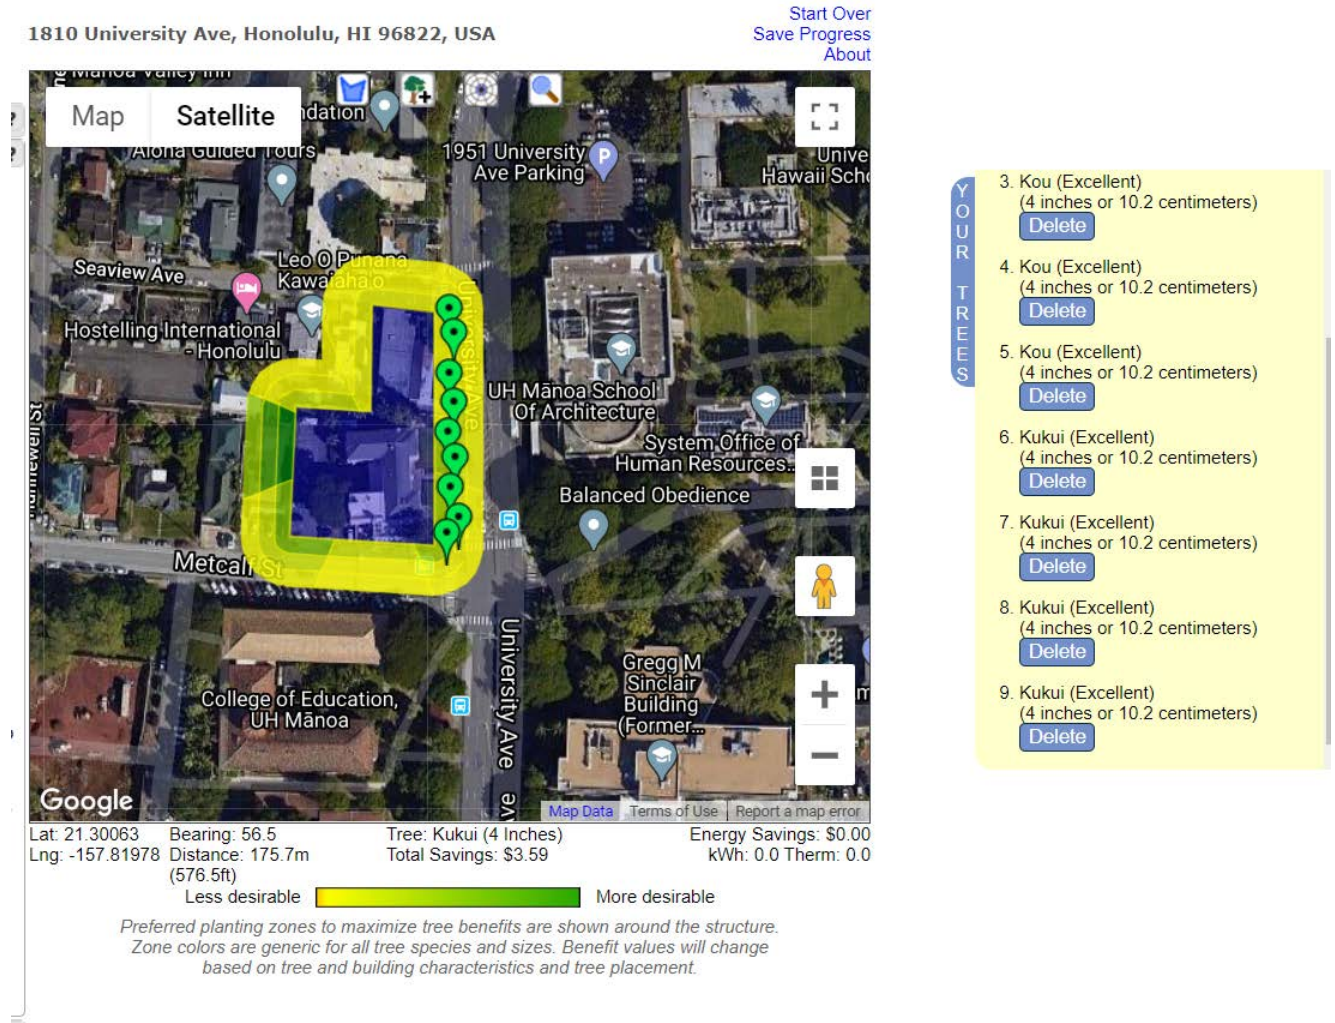
Figure 6, Propose tree planting sites around the redeveloped building. The yellow and green ring denote the ideal effect of placement of trees to reduce energy saving. Only the proposed new trees are shown. The Kukui and Kou are planted in alternated fashion.

With the limited planting space and canopy volume next to the building, it will be very difficult to replace the 14 mature trees on the property in year one. Our strategy is to use medium sized trees to gradually replace the ecological benefits of these trees over time. We recommend 10 medium sized trees for the front of the new building. The replacement trees will be set back at least 6 feet from the sidewalk to allow root growth. These trees will be pruned to an 8 foot clearance for pedestrian access and view planes for vehicles traffic. We recommend an alternated mix of two species, Kukui and Kou, to provide biodiversity and aesthetics. In figure 6, we outlined the placement of these trees to compliment the proposed building facade. Ideally these trees could provide better cooling benefits if they are placed on the makai side of the building as suggested in the diagram. The yellow and green color rings denote how the cooling benefits can be improved. Having them on the east side, will still provide some cooling benefits from the mid morning sun, especially during the summer months.

This benefit analysis is based on planting 2 inches diameter young trees for the duration of 50 years, the duration of the contract. We have chosen a younger tree at 2-inch versus a 4-inch diameter because their adaptation ability is higher. The choices of trees from the nursery are better. Over time, these trees will join the Kiawe and Tamarind to acquire woody mass and intercept storm water run off for the entire eastern side of the property. Together they will intercept more than 1.6 million gallons of stormwater. The detailed ecological benefit report for the proposed trees is attached in [Appendix A](#).

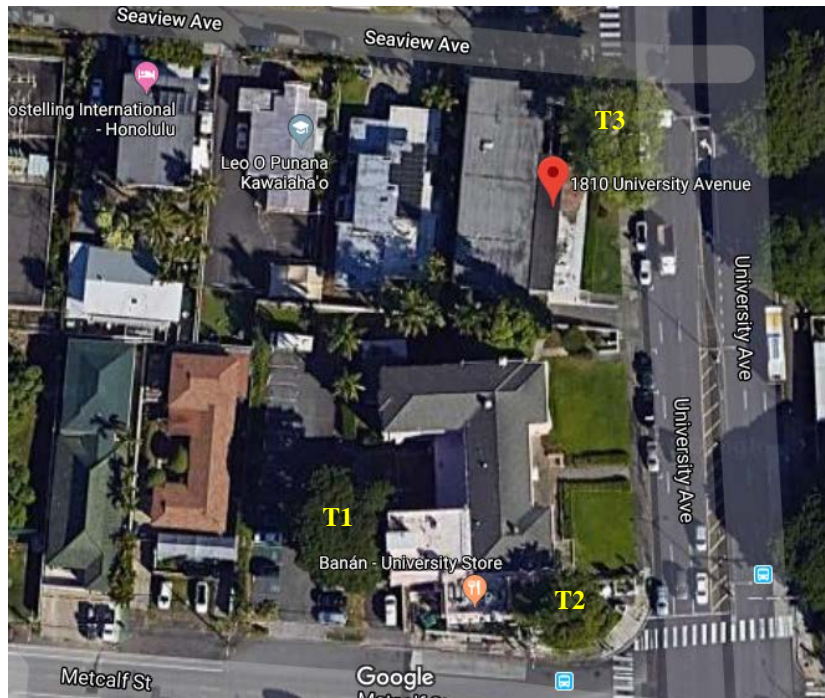
Approximate Location of Subject Trees

This tree risk assessment has been prompted by concerns for the health of three trees on the site.
